Fuse On-Going Reliability Test Summary Report - 0ALCX Fuse series

Fuse Type and Rating : 0ALCX 50A/60A/70A/80A

Project Number : FPQ-157

Fuse Part Number : 0ALCB9500-BD/0ALCB9600-BD/0ALCB9700-BD/0ALCB9800-BD

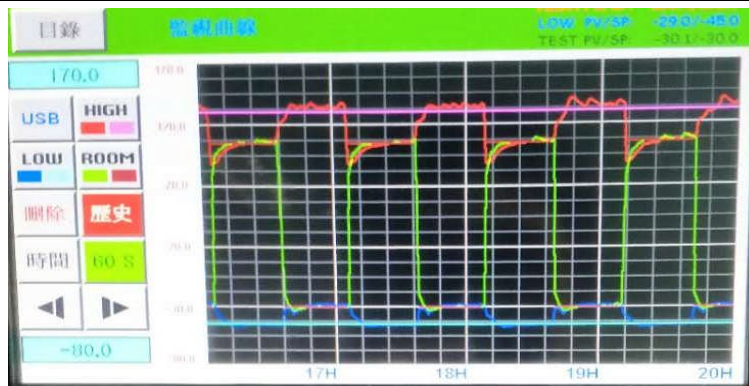
Thermal shock resistance test

Condition : JASO D622 6.3.6

The condition of a single cycle:

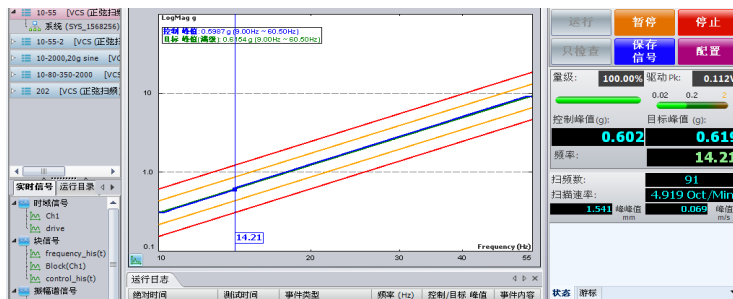
Condition : 50A/60A/70A : JASO D622 6.3.3 80A:QC/T895-2011, Sec.7.8.1
